Analysis and Preservation of Marble in Archaeological Buildings

Mohammed K. Khallaf

Conservation Department, Faculty of Archaeology, Fayoum University, Fayoum, Egypt.

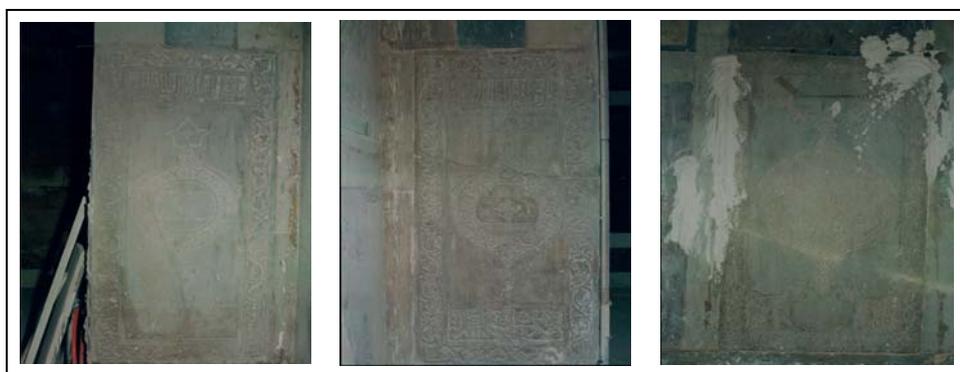
Fig (1) a: Photos of marble objects from Prince Saraghatmash Madrasa shows dirt layer, sun natches and black incrustation

The first stage of the treatment and conservation was to remove the dirt layer to reveal the marble surface. Loose dust was first removed with a vacuum cleaner⁽¹¹⁾ then mechanical cleaning has been carried out using manual tools. Chemical cleaning has been carried out using a solution of 100 cm³ distilled water, 10 gm non-ionic surfactant and 1 cm³ Ammonia then mora poultice used⁽¹²⁾, it consists of 60 gm ammonia bicarbonate, 60 gm sodium bicarbonate, 60 gm carboxy methyl cellulose, 25 gm ethylene di-amine tetra- acetic acid, 10 gm fungicide (cetavlon) in 1 liter of

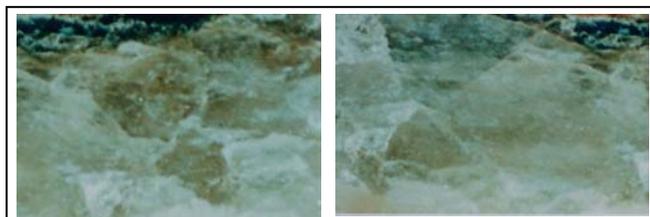
Examination shows that very inequigranular grains of calcite, saccharoidal texture of marble and black, reddish, fine, atmospheric particles and grains of quartz, fig (2). In addition to yellowish-grey, translucent crust. It is a mosaic texture, almost devoid of porosity.

Fig (2) Polished sections of marble objects show very inequigranular grains of calcite and black crust.

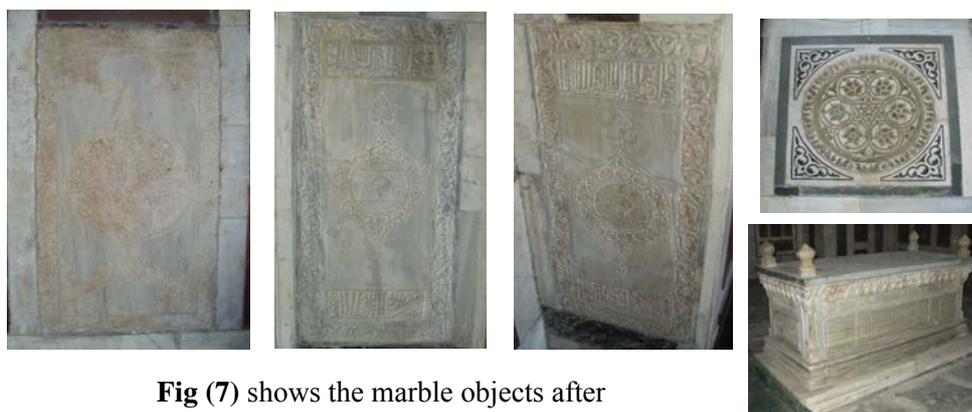
Fig (7) shows the marble objects after treatment

distilled water. The poultice in the form of a clear jelly, is applied to a pre-wetted surface by spatula or by brush to a thickness of 3-4mm and is covered at once with thin poly ethylene film to prevent drying out and it leave for twenty four hours, then it was removed Then, the surface washed with distilled water. Stainless steel rods were used with Araldite AY 103 (20%) and marble powder to reinforce, fix and complete the disintegration parts⁽¹³⁾ in the marble cenotaph of the mausoleum. Iron stains have been removed by applying a five percent solution of sodium dithionate in poultice sepiolite clay. The poultice was covered with thin film of poly ethylene for twenty four hours then it was removed.⁽¹⁴⁾ Consolidation and isolation of all marble objects have been carried out with Rohdorsil RC 90 (5% in white spirit). Fig (7) shows the marble objects after treatment and conservation.
