**Deterioration of Limestone and Marble- A Case Study on the Mausoleum of As-Saleh Nagm Ad-DIN Ayyub in Cairo
(Monument no.38) (641-648 A. H. /1243-1250 A.D.).**

Summary -The mausoleum of As-Saleh Nagm Ad-Din Ayyub in Cairo (Egypt), built with limestone and marble for the portal is heavily weathered, due to damp rising from the ground. The deterioration phenomena affected the building materials were studied and the causes that led to them were determined. In order to achieve this study different analytical techniques were used, including X-ray diffraction, atomic absorption spectroscopy and ion chromatography. Determination of the mobile cations and anions concentrations in the aqueous extractions from selected samples followed by statistical study of the obtained results were carried out to identify the abundant salts. The study proved that, three salts affected the building, produced five deterioration phenomena, and the saline solutions from the ground which transported by rising water are the main source of the formed salts. The results have been reported and discussed.

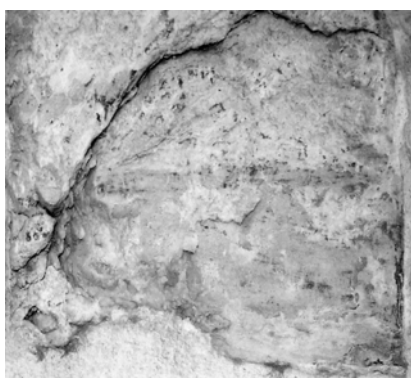
Scales (Fig. 1), salt efflorescence (Fig. 2), salt sub-efflorescence (Fig. 3) cracking (Fig. 4), and big dark spots of humid aspect (Fig.5). The first four typologies were restricted at height between 1 m and 3 m above ground while the last one appeared restricting at

Fig. 1. Scales, one of the common superficial detachment forms.

All soluble salts occur at least in the most places where deterioration occurs,⁽²⁾ they may produce very strong decay⁽⁷⁾, and provoke the alteration of the blocks by detachment and exfoliation etc.⁽¹⁶⁾ Therefore the present study attributes both scales and cracking phenomena affected the façade of the mausoleum to gypsum formation in sub-efflorescence form and this corresponds with literature⁽¹⁰⁾ which attributed plaques phenomenon which is similar to scales to gypsum occurrence because the crystallization of it and its recrystallization from a lower to a higher hydrate within the range of mineral stability may develop stresses of high magnitude.^(13, 14)

Gypsum occurrence is responsible for both scales and cracking phenomena, while antarcticite and nitrocalcite existence in the walls are responsible for the big dark spots of humid aspect phenomena.

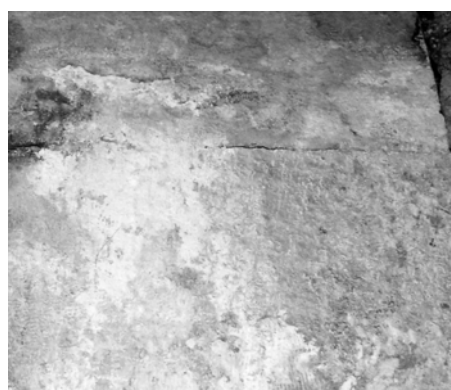
Fig. 2. The concentration of soluble salts present on the wall surface; as efflorescence.

It was observed that, the broad occurrence of gypsum in the efflorescence form and this corresponds with what was mentioned in literature⁽¹⁵⁾, and also in the sub-efflorescence form as shown in (Figs. 2 and 3) respectively.

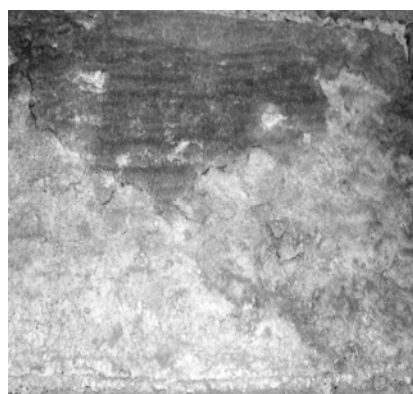
Fig. 3. The concentration of soluble salts present on the wall subsurface; as sub-efflorescence.

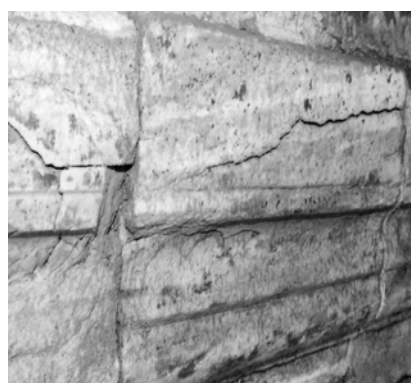
Fig. 4. Cracks extend in an irregular way close to the horizontal.

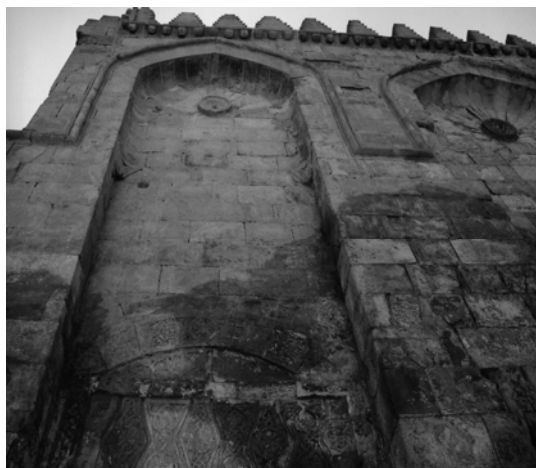
Fig. 5. A common characteristic of the mausoleum and most monuments built in Fatimid Cairo city; the big dark spots of humid aspect.

proved the presence of both antarcticite and nitrocalcite. How can one explain this? The chloride and nitrate of Ca^{2+} form very hygroscopic salts.⁽⁵⁾ These hygroscopic salts can absorb moisture from the ambient humid air, when the relative humidity is higher than the equilibrium relative humidity of the saturated solution.⁽⁴⁾ So the salts will dissolve and the wall in contact with the salt solutions gets moist. Antarcticite does that at relative humidity above 30% and nitrocalcite at relative humidity above about 55%.⁽⁵⁾ This means that antarcticite cannot crystallize under normal conditions on walls.⁽³⁾ The present study confirms that, the relative humidity around the mausoleum is very high because of the continuous supply of rising damp from the ground; therefore the study attributes the big dark spots of humid aspect phenomenon affected the two highest zones D and E to this behavior of these two hygroscopic salts. This also explains; why are these two higher zones more humid than the three lower zones.

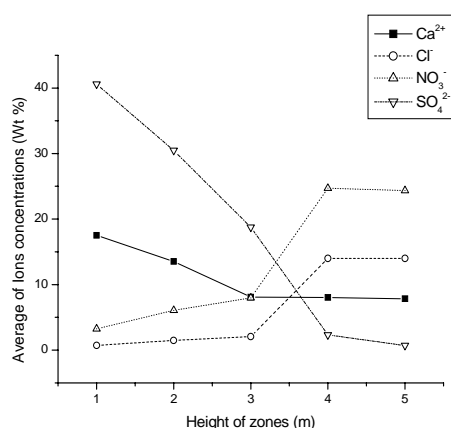
The results revealed that, the concentrations of SO_4^{-2} are very high in the first three zones and very low in the last two zones namely zones D and E which affected by the big dark spots of humid aspect, in the opposite of the behavior of both Cl^- and NO_3^- which their concentrations are very low in the first three zones and very high in the last two zones as shown in (Fig. 6).

This can be explained as follows: the water evaporates and the solutes concentrate, and the different salt phases will precipitate in sequences according to their solubilities when and where the solution becomes supersaturated.⁽⁸⁾ Thus, as shown in (Fig. 6); the less soluble sulphate is concentrated and enriched in the lower zones and the more soluble nitrate and chloride in the upper zones.

Fig. 6. Distribution of Ca^{+2} , Cl^- , NO_3^- and SO_4^{-2} ions in relation to height on the façade of the mausoleum

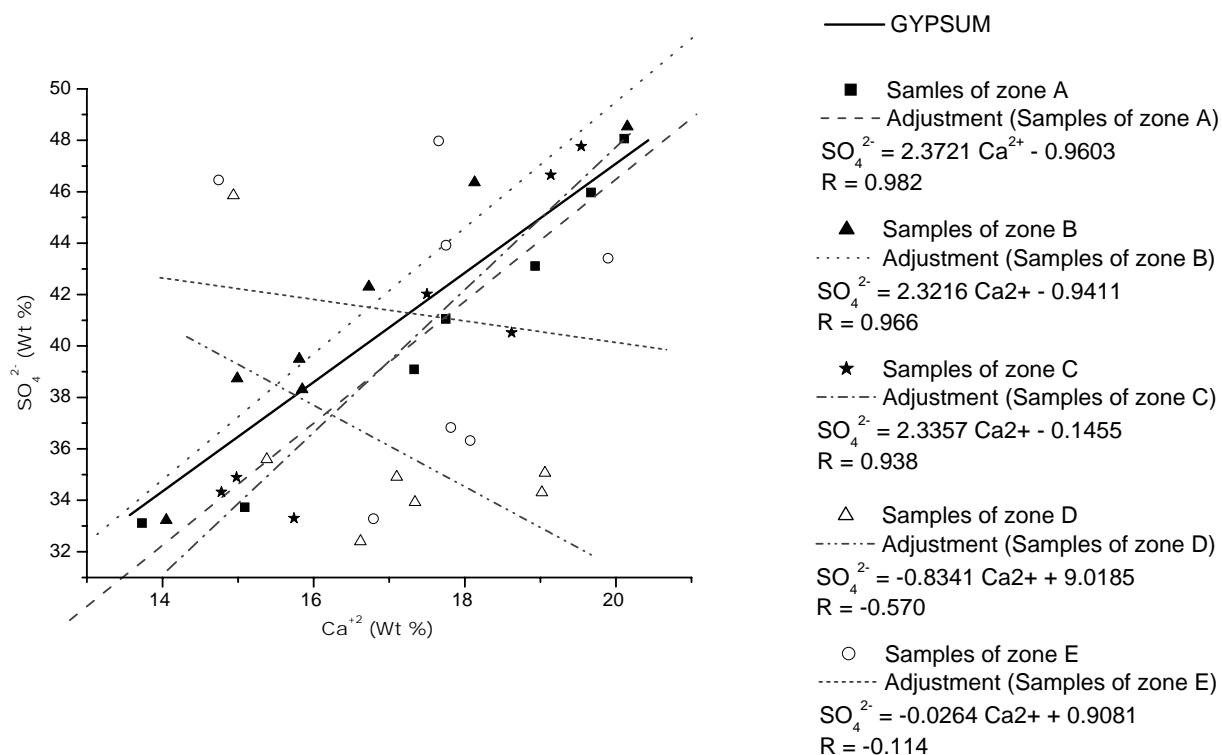
The correlation coefficients were calculated between the ions values; the matrices can be shown in table 2. The obtained results can be summarized as follows: strong linear correlation coefficients ($R = 0.982$, $R = 0.966$ and $R = 0.938$) associated with the equations $SO_4^{2-} = 2.3721 Ca^{+2} - 0.9603$, $SO_4^{2-} = 2.3216 Ca^{+2} - 0.9411$ and $SO_4^{2-} = 2.3357 Ca^{+2} - 0.1455$ were obtained between the Ca^{+2} ion values on one hand and the SO_4^{2-} ion values on the other hand in the aqueous extractions from the samples of zones A, B and C respectively. Besides, these equations are very similar to the $SO_4^{2-} = 2.3967 Ca^{+2}$ equation of gypsum. Basically this means that, all Ca^{+2} ions combine with SO_4^{2-} ions crystallizing as gypsum during water evaporation; while their values of zones D and E did not allow good correlations as shown in (Fig. 7).

Fig. 7. Statistical correlation between the Ca^{2+} and SO_4^{2-} values of the chemical analyses carried out in the aqueous extractions from stone samples of five zones.

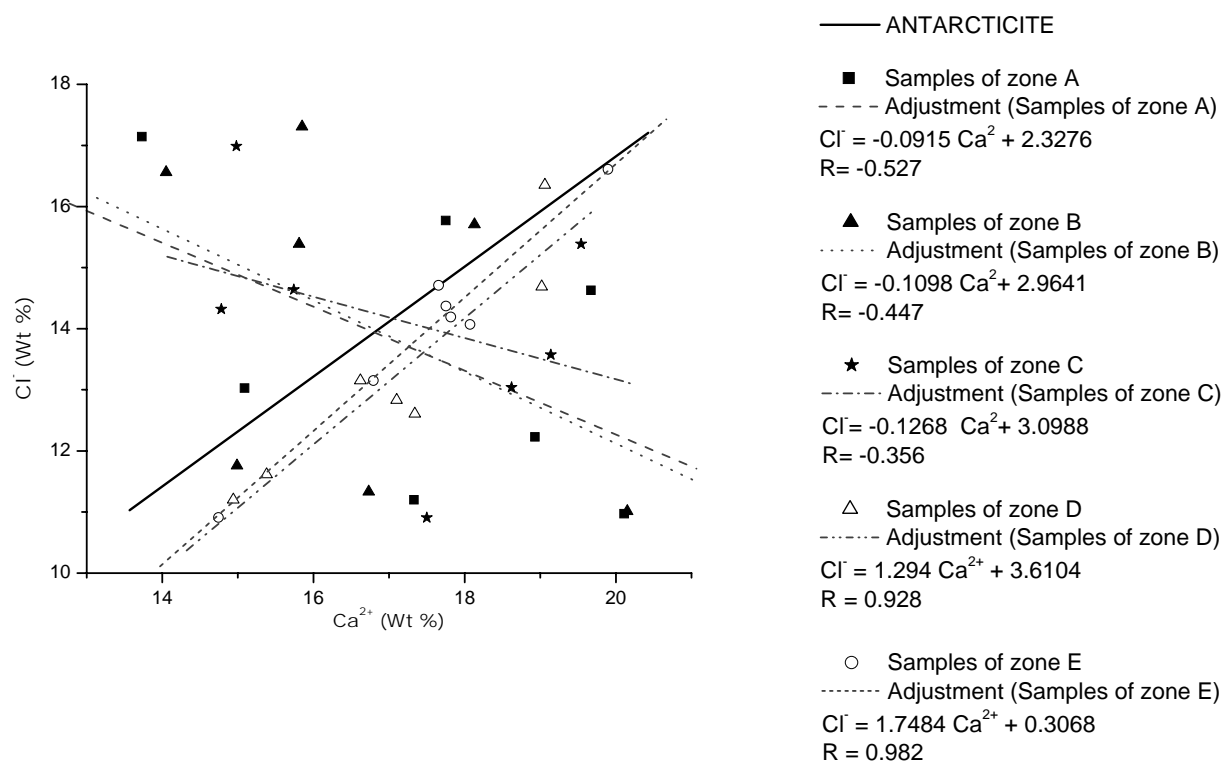
Concerning the Ca^{+2} and the Cl^- values in zones A, B and C, they did not allow good correlations; while strong linear correlation coefficients ($R = 0.928$ and $R = 0.982$) were obtained between their values in zones D and E associated with the equations $Cl^- = 1.294 Ca^{+2} + 3.6104$ and $Cl^- = 1.7484 Ca^{+2} + 0.3068$ respectively. Besides, these equations are very similar to the $Cl^- = 1.7691 Ca^{+2}$ equation of antarcticite as shown in (Fig. 8).

Fig. 8: Statistical correlation between the Ca^{2+} and Cl^- values of the chemical analyses carried out in the aqueous extractions from stone samples of five zones.

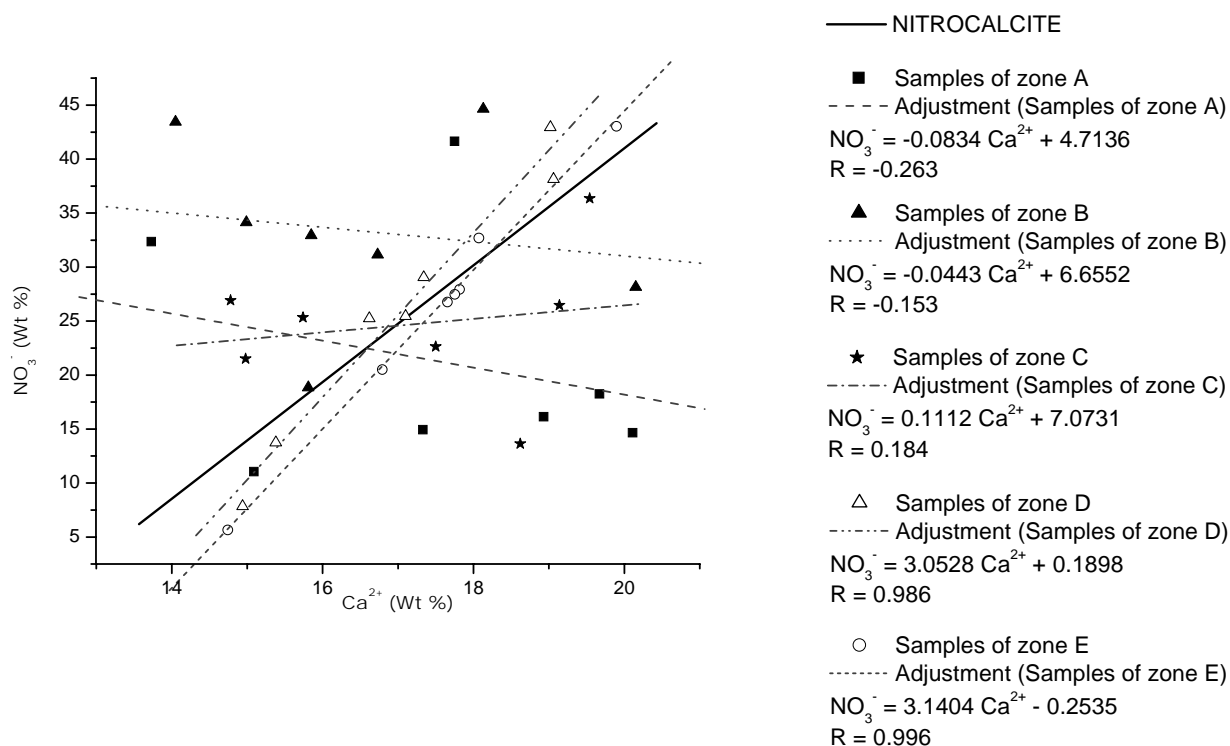
Concerning the Ca^{+2} and the NO_3^- values in zones A, B and C, they did not also allow good correlations; while their values in zones D and E allowed strong linear correlations ($R=0.986$ and $R=0.996$) associated with the equations $NO_3^- = 3.0528 Ca^{+2} + 0.1898$ and $NO_3^- = 3.1404 Ca^{+2} - 0.2535$ respectively. Besides, these equations are very similar to the $NO_3^- = 3.0940 Ca^{+2}$ equation of nitrocalcite as shown in (Fig. 9).

Fig. 9: Statistical correlation between the Ca^{2+} and NO_3^- values of the chemical analyses carried out in the aqueous extractions from stone samples of five zones.

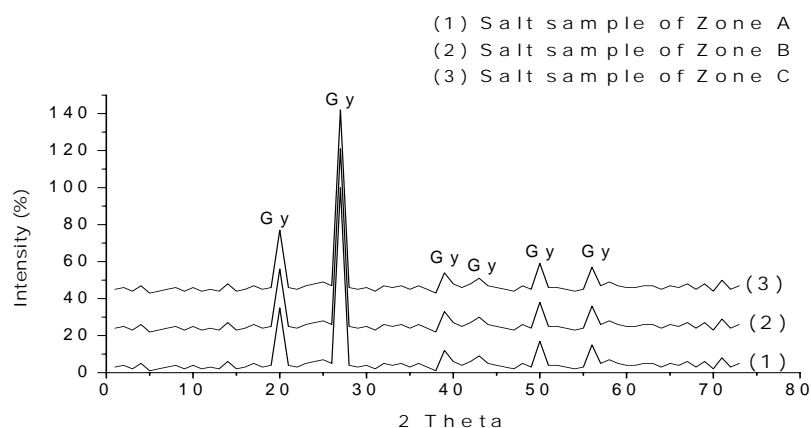
X-ray diffraction analysis of the taken samples from the first three zones A, B and C proved the presence of gypsum salt as shown in (Fig. 10).

Fig. 10. X-ray diffraction patterns of salt samples taken from the first three zones
