## **Role of Investigations and Analytical Methods in Study of Archaeological Stone Ornaments's Deterioration and its Treatment**

**Mohammed K. Khallaf and Shehata A. Abd El- Rahim**

*Conservation Department, Faculty of Archaeology, Fayoum University, Fayoum, Egypt.*

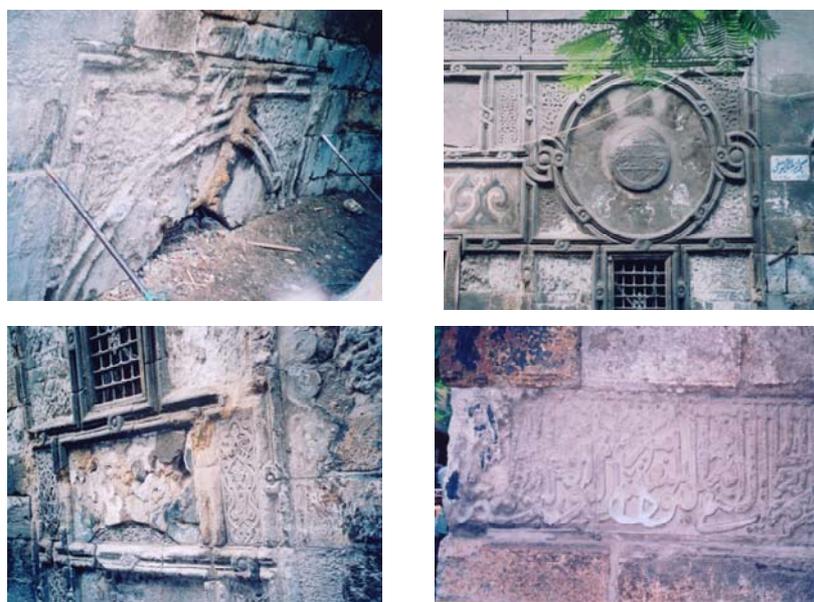
**Fig. (1)** Photos of Azbak limestone ornaments showing erosion, efflorescence of salts, discoloration, chipping and disintegration between grains.

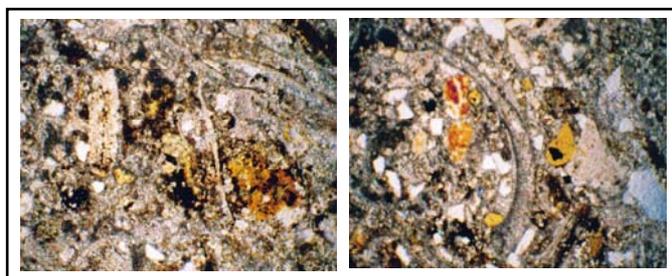
Two types of limestone samples were examined and, it was found that: the yellow limestone under PLM consists mainly of fine-grained calcite crystals besides presence of iron oxides, quartz, clay minerals and fossils fig (2) while, the white limestone includes nummulite fossils in a fine-grained matrix (biomicrite) besides presence of clay minerals, a little amount of iron oxides and some grains of quartz Fig (3) these components increase the rate of stone decay.<sup>(11)</sup>

**Fig. (2)** Thin section photomicrographs showing iron oxides, clay minerals, fossil and grains of quartz in a mass ground of fine-grained calcite. 4X (C.N).

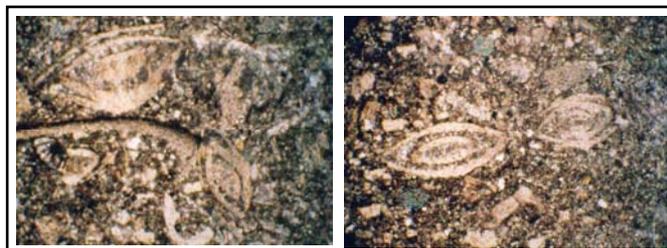
**Fig. (3)** Thin section photomicrographs showing equatorial section of nummulites Sp., clay minerals in a fine-grained matrix (biomicrite). 10X (C.N).

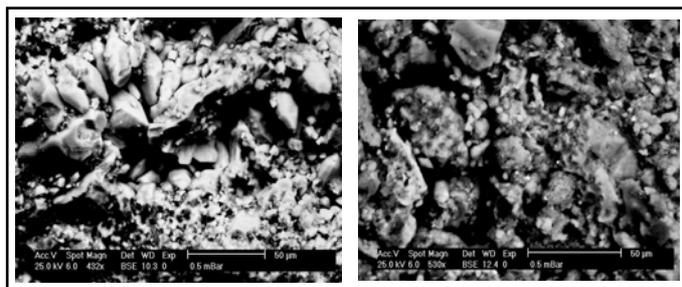
When the limestone samples were examined by [SEM], disintegration between calcite crystals and the stone lost the binding materials between grains by the effect of salts crystallization were found,<sup>(12)</sup> Fig. (4).

**Fig. (4)** SEM photomicrographs showing the collaps of internal structure and salts crystallization between grains of limestone ornaments.

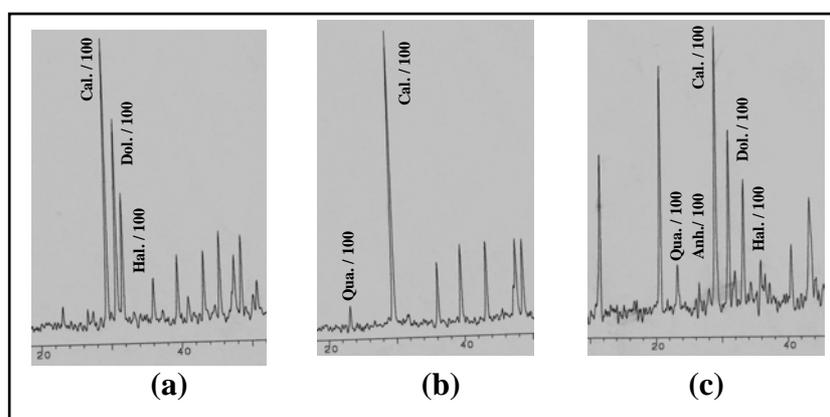
XRD data shows that, the yellow limestone consists of calcite  $\text{CaCO}_3$ , Card No. (5-0586) in addition to dolomite  $\text{Ca,Mg}(\text{CO}_3)_2$ , Card No. (11-078), and halite,  $\text{NaCl}$  Card No. (5-0628) Fig. (5-a). The white limestone consists mainly of calcite in addition to quartz  $\text{SiO}_2$  Card No. (5-0490) Fig. (5-b). The mortar consists of calcite, dolomite, quartz in addition to halite; gypsum Card No. (6-0046) and anhydrite, Card No (6-0226) Fig. (5-c). When the water evaporates from soluble salts as chlorides, it leaves behind concentrations of salt solutions which crystallize on the stone surfaces and between mineral grains of stone, this process cause disintegration and deterioration of stone.<sup>(13)</sup>

**Fig (5)** shows XRD patterns of a: yellow limestone, b: white limestone, c: mortar

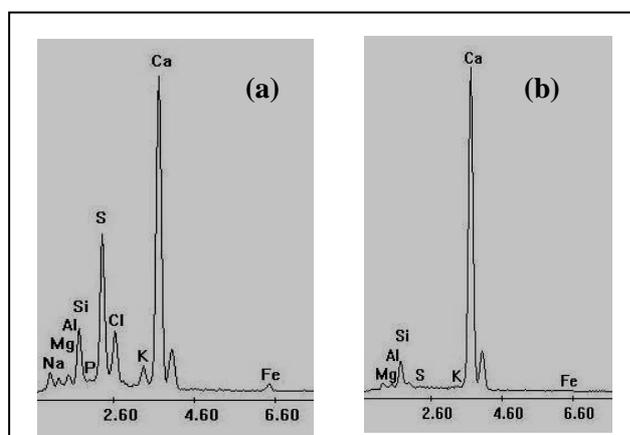
EDX data shows high content of calcium related to calcite mineral, silicon and aluminum due to clay minerals, silicon due to quartz mineral, iron related to iron oxides, sodium and chlorine due to presence of halite salt fig (6).<sup>(14)</sup>

**Fig. (6)** shows EDX patterns of limestone ornaments of Azbak Al Yusufi Madrasa . a: yellow limestone. b: white limestone .

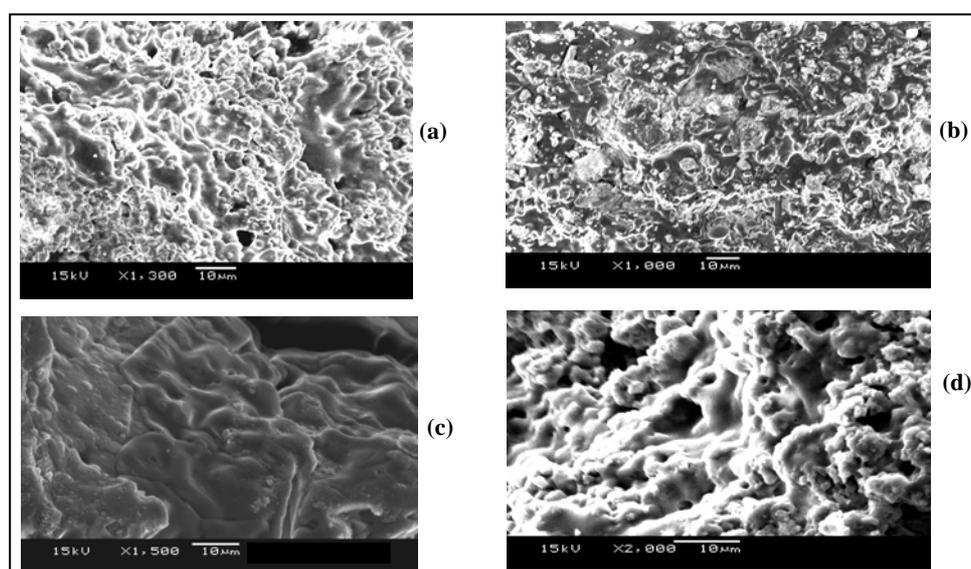
**Fig (7)** SEM photomicrographs after treatment  
 a: the forming of resin Estel 1000 with best penetration depth.  
 b: the forming of resin Nitocote SN 502 with best coating.  
 c: thick layer of paraloid –B82.  
 d- the forming of resin wacker 1311.

Stone samples which have been treated with polymeric products and exposure to artificial weathering show that Estel 1000 (maximum increasing of compressive and tensile strength) given the best result in consolidation and Nitocote SN 502 (maximum reducing of porosity and water absorption) given the best result in Isolation of stone surfaces, total results seen in table No. (1) Estel 1000 and Nitocote SN 502 don't change stone surface color, examination by SEM shows good penetration and good coating of stone, Fig. (7).
